## Brook Road Culvert Replacement

### Full Mitigation Best Practice Story

#### *Cumberland County, Maine*

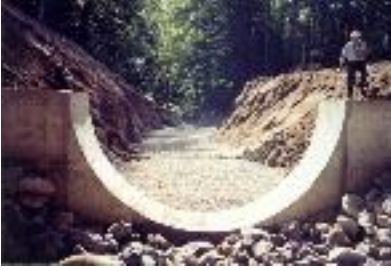
To hold the new large culvert in place, two pipe cradles were installed.

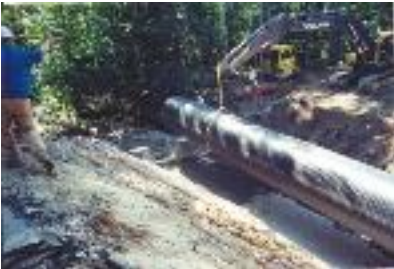
Three 40-foot long sections were lowered as one pipe into the excavation.

The project included excavating the ravine on Brook Road and replacing undersized culverts with a 90-inch high-density polyethylene pipe. This pipe was transported to the site in three 40-foot sections. With the new pipes laid end to end, crews joined them on-site with an extrusion weld to form a single unit. A clay base and fill prevents stream infiltration and scouring around the pipe. Concrete headwalls were also installed. Lastly, the fill was added, enabling the road to be widened to allow for a shoulder, guard rails, and a slope.

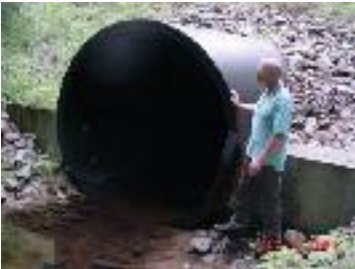
Falmouth Public Works Director Tony Hayes examines the new 90-inch culvert.
